Fukushima Nuclear Crisis

March 15, 2011

Congressional Research Service

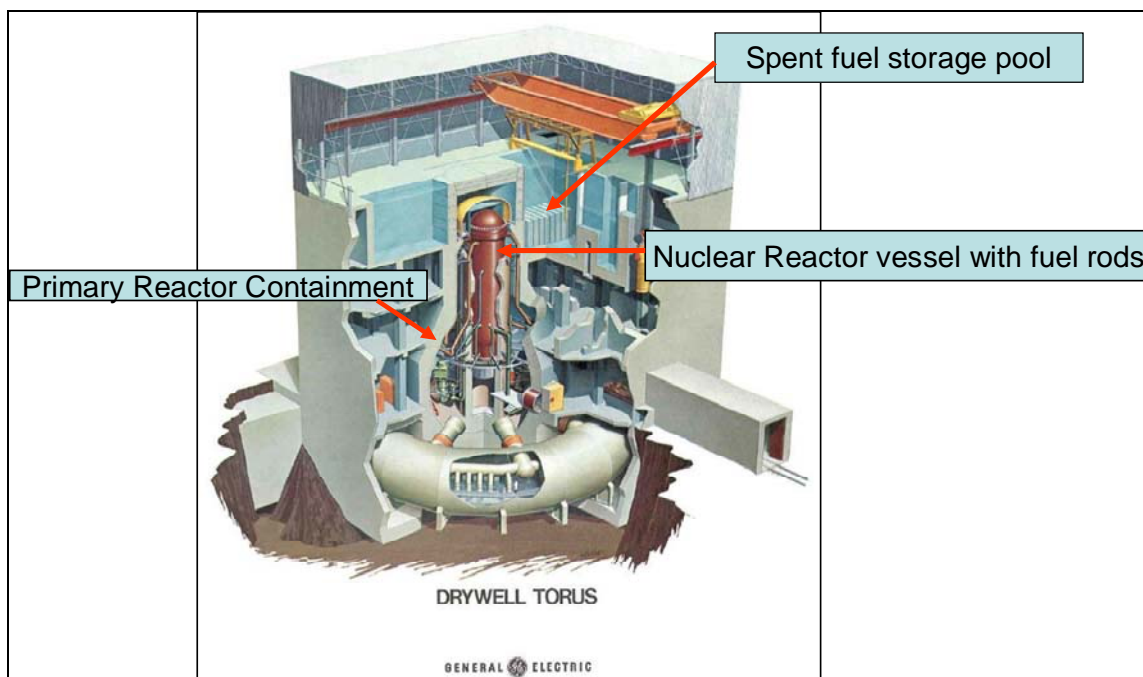
Figure 2. General Electric Mark I Boiling Water Reactor and Containment Building

² A common nuclear power reactor design in which water flows upward through the core, where it is heated by fission and allowed to boil in the reactor vessel. The resulting steam then drives turbines, which activate generators to produce electrical power. BWRs operate similarly to electrical plants using fossil fuel, except that the BWRs are powered by 370–800 nuclear fuel assemblies in the reactor core rather than burning coal or natural gas to create steam. U.S. Nuclear Regulatory Commission, “Boiling-Water Reactor (BWR),” <http://www.nrc.gov/reading-rm/basic-ref/glossary/boiling-water-reactor-bwr.html>.
